NASA Contractor Report 166002

Flight Service Evaluation of Composite Components on the Bell Helicopter Model 206L: Design, Fabrication, and Testing

**Bell Helicopter Textron Inc.
Fort Worth, Texas**

**Contract NAS1-15279
November 1982**

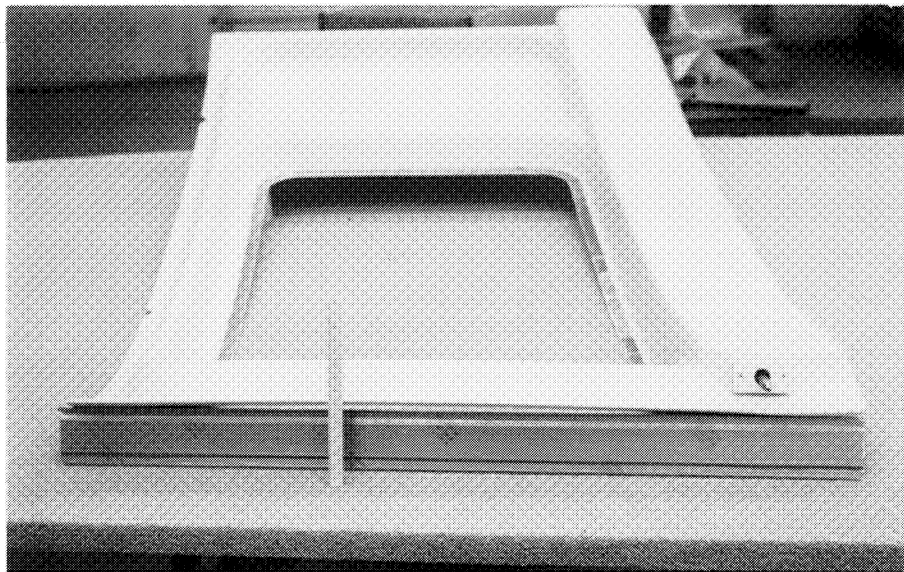
b. Bow of edge.

Figure 15. Litter door bow caused by flexibility of fixture.

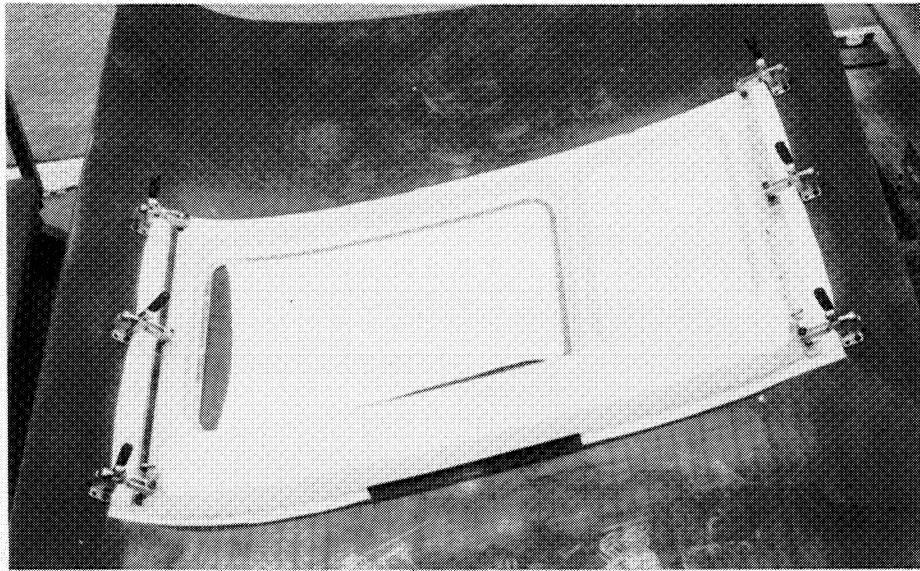
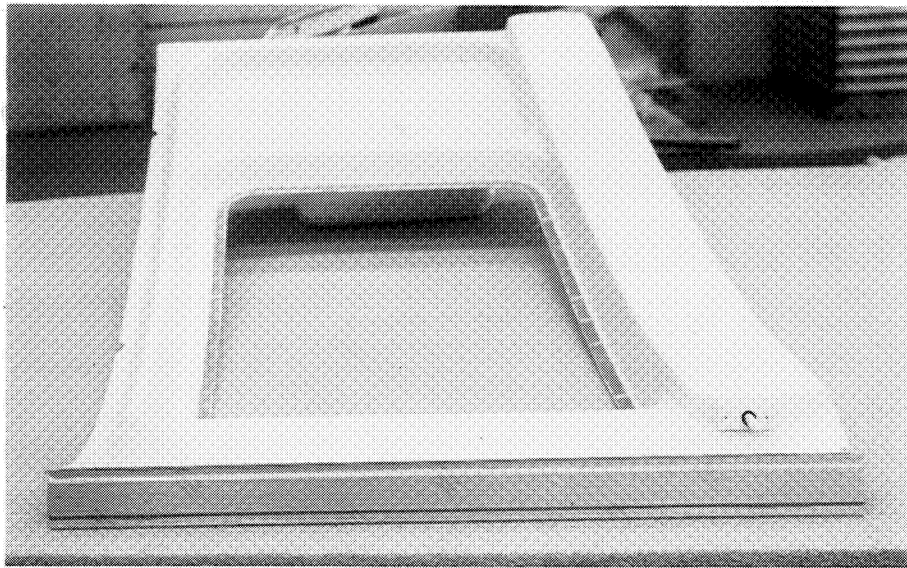
Figure 16. Straightening of bow in composite litter door.

It was necessary to remove the plexiglass window before the door was straightened because of the large difference in thermal expansion between the plexiglass and the Kevlar/epoxy. After the straightening process, the window was replaced.

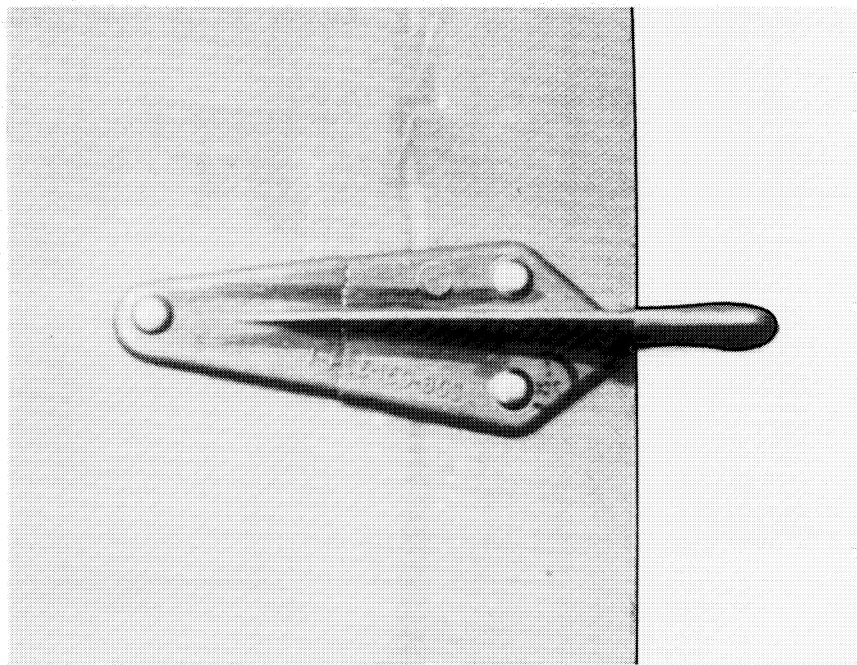
For the pressure test, the door was tested in the fixture shown in Figure 22a. The door was attached to the jig by two hinges and latches. Pressure was applied by means of water bags. Failure occurred at 0.794 psi, or a total of 695 pounds in the metal hinges, as shown in Figure 22b. This is technically a margin of safety of 13.4 percent, but is based on a metallic hinge failure, not a failure of the composite material.

b. Static test failure of hinge

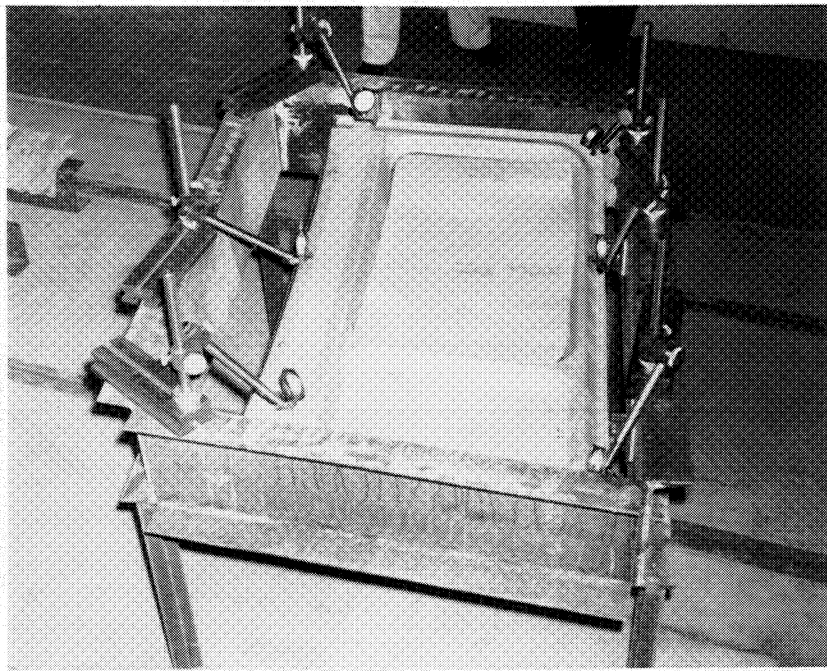
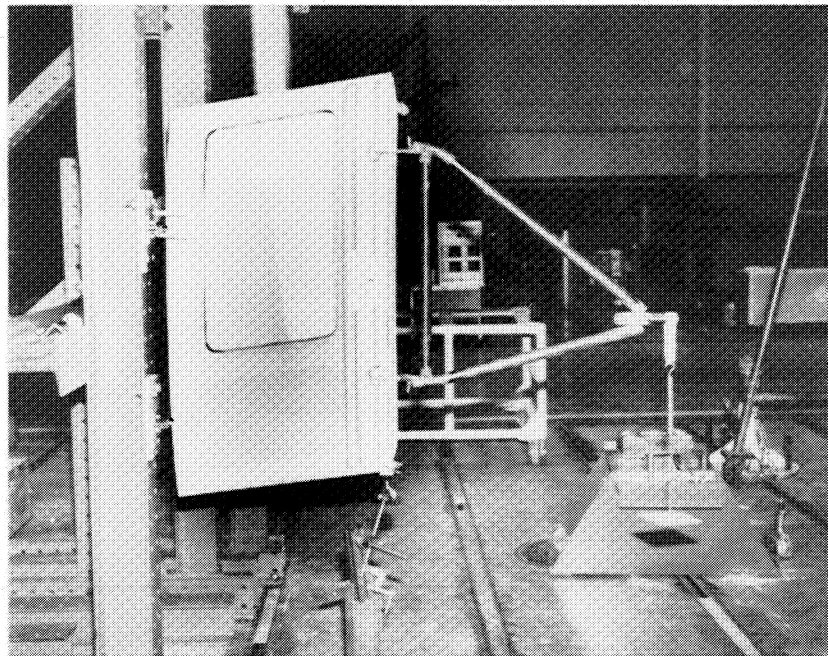
Failure occurred at 0.55 psi pressure (634 pound), 152 pounds at the upper hinge and 390 pounds at the lower hinge. This is between 95 and 99 percent of the required strength if the failure were in the composite material. However, failure was caused by the hinge pin slipping out of the latch, not by failure of the composite material, and for this failure the knockdown factor is not applicable. On this basis the strength of the door was certified by the FAA.

The cantilever test setup is shown in Figure 24b. At 415 pounds of load the door hinges rotated excessively to the point where it was not possible to load any higher in this manner. Since a failing load test was required, the load application point was moved directly to the litter door hinges. This reduces the cantilever moment, but eliminates the rotation of the hinges. Failure occurred at 833 pounds when loaded in this manner, and the failure occurred by compression buckling at the lower forward corner.

Figure 24. Static tests of composite litter door.

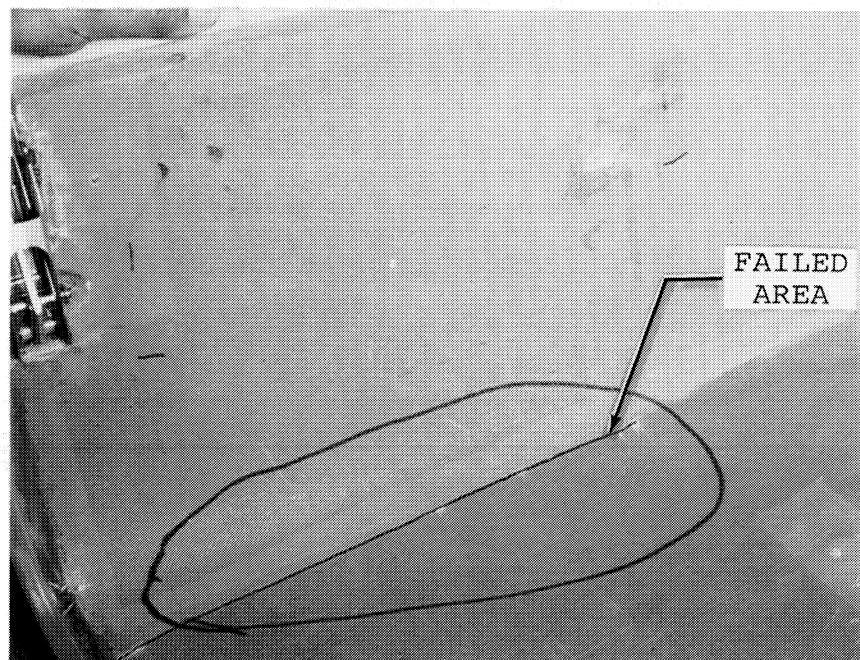
Two fairings were tested to failure. The first one failed at 1.51 psi at the inner corner splice, as shown in Figure 27. The second fairing failed at 1.94 psi, but was not a composite failure. At 1.94 psi the right-hand aft latch slipped, causing some local, noncatastrophic failures of the surrounding structure.

Subsequent examination of the test parts revealed a possible knife cut in the failed area of the first specimen and the probability of a faulty latch on the second specimen. (The much higher load that five subsequent fairings withstood supports this theory. This is discussed in Section 6.2.6).

Figure 27. Forward fairing failure.

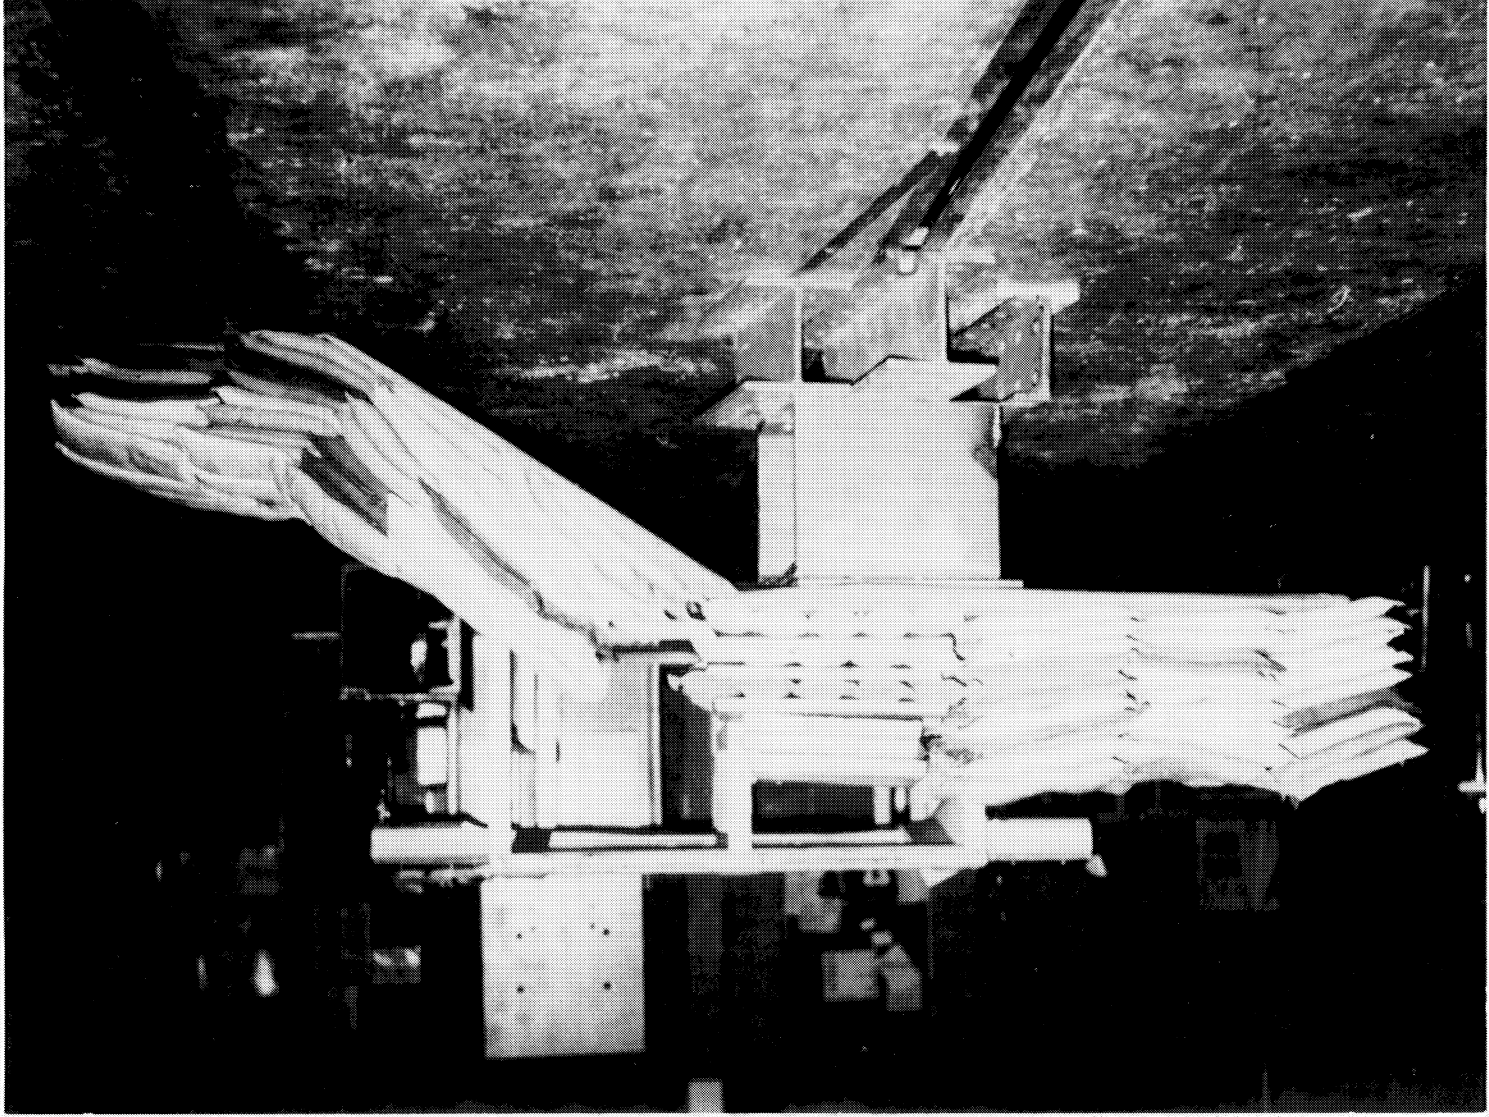
Examination of the failed area revealed two facts: first, that the area had been overheated and was probably partially disbanded before the test was started. Second, that the overheated area was sufficiently localized for the fin to be used for the aerodynamic test.

Figure 32. Fin static test failure - aerodynamic loading.

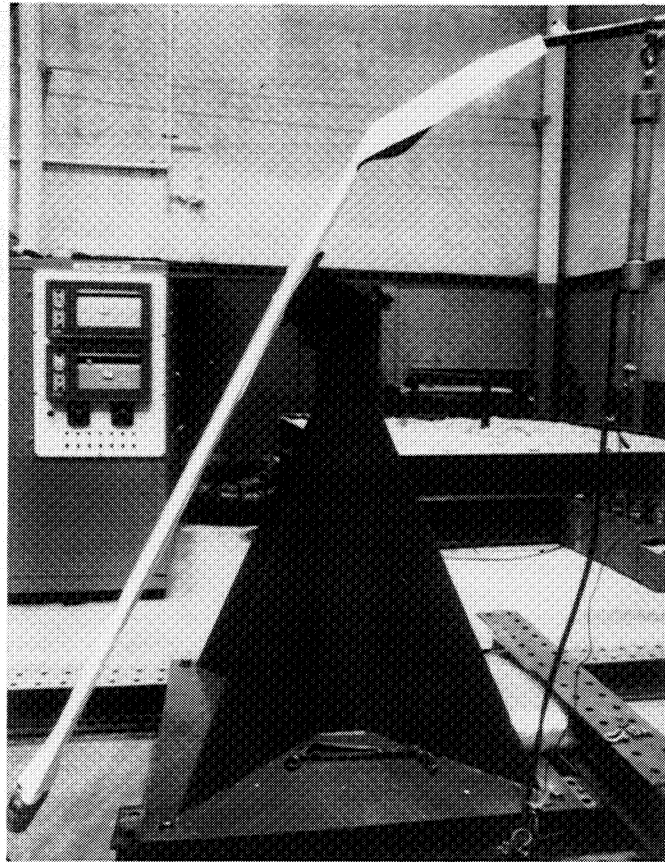
Figure 33. Fin static test failure - tail down landing.
